## **REVAMPING FOR BETTER INDOOR AIR QUALITY IN HOUSING: A RENTAL HOUSE RENOVATION IN HO CHI MINH CITY, VIETNAM**

**Abstract.** Over the past decade, the population of Ho Chi Minh City (HCMC) has doubled, resulting in a rise in low-income hostels. Rental homes for low-income families are usually small, ranging from 12 to 15 square meters, serving as a multi-purpose space. This type of accommodation is the most suitable option for those who cannot afford larger housing. This article aims to assess the effect of ventilation-related renovations on indoor air quality through a case study of a rental house in HCMC. Fieldwork was conducted to collect information on the house's original state, followed by renovations. Air pollutants, such as CO<sub>2</sub>, CO, PM<sub>2.5</sub>, and TVOC, were measured before and after renovation. Further analysis was conducted to identify factors that could enhance ventilation conditions in the house. The findings indicated that using exhaust fans with louvers and frequently opening doors and windows significantly improved indoor air quality. Therefore, mechanical ventilation is a simple and effective intervention to improve indoor air quality in tiny h

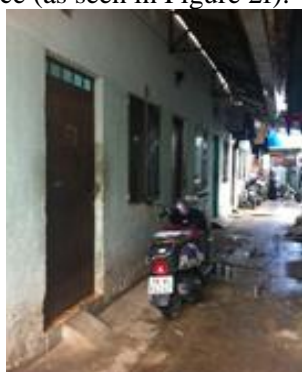
(a) A row of rental houses was where our sample house was located on the left side.

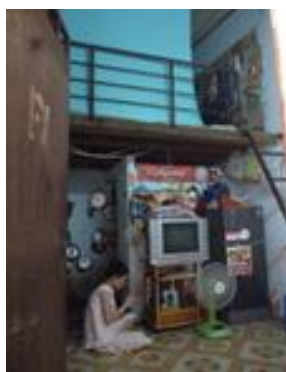
(b) The living area

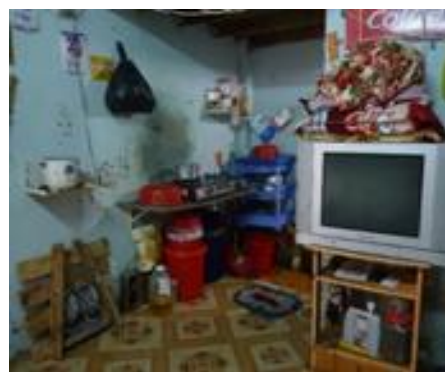
and had indoor pollutants that were difficult to exhaust. In addition, the occupants of the house needed to be cooperative and knowledgeable enough to address any feng shui issues and allow for remediation. Finally, the sample house designated as REN-05 in the previous study (Figure 2) met all these requirements. The sample house was a typical low-income rental property in a housing block with two rows of small units, expected in new urban areas in Ho Chi Minh City (Figure 2a). The people who lived here were sewing clothes all day, releasing a lot of dust. The owner of the rental house was a kind man who assisted in choosing a place with a couple as occupants. The husband worked while the wife was pregnant and stayed home all day. The owner helped monitor the equipment and allowed us to renovate the house later. Gas and electric stoves were commonly used in rental houses due to their compact size and convenient features. Some residents used gas for cooking in combination with other fuels such as oil, coal, electricity, or wood to boil water or prepare street food for sale. In this case, the occupants cooked using a gas stove for less than 1 hour daily (from 18:00 to 19:00) due to their simple cooking style (Figure 2c).

(c) The cooking area, equipped with a gas stove

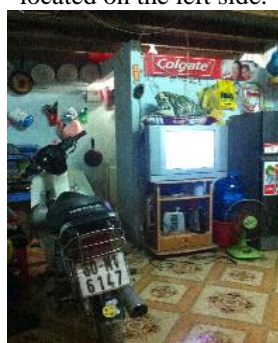
In Vietnam, it is common for families to park their vehicles inside their homes, as the size of scooters and motorbikes allows them to fit comfortably within living spaces. This sample rental house was no exception, as an old motorbike was stored inside, and the room took on the scent and felt of a garage during nighttime hours. The house's surroundings were composed of a large, unpaved soil area, which contributed to high levels of dust and dirt entering the home, particularly in areas without vegetation or trees to keep the soil in place (as seen in Figure 2f).

(d) The motorbike was stored inside the house

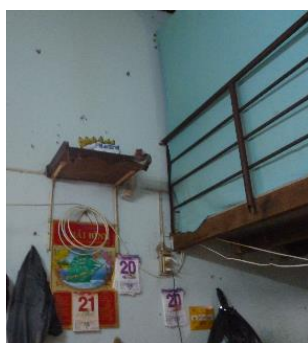
(e) Worship locations where incense was burned for religious purposes

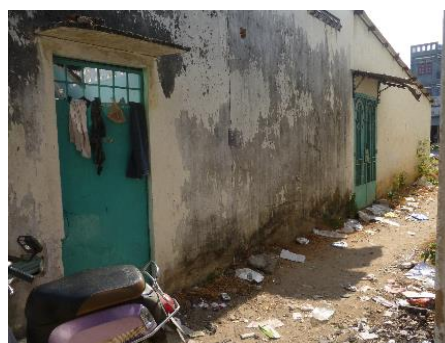
(f) The soil surrounding the house was not paved with concrete.

problem with the soil surrounding the house not being paved with concrete, which led to a high loading of particulates that could be carried into the house, resulting in a minimum background value of  $35 \mu\text{g}/\text{m}^3$  at night, which was higher than the WHO standard.

The PM<sub>2.5</sub> concentrations were already at concerning levels of 25µg/m<sup>3</sup> in nearly 90% of readings prior to the renovation work. However, the average PM<sub>2.5</sub> levels sometimes even rose after the renovation was completed. The lack of concrete paving around the house resulted in a large influx of particulate matter each time the door was opened, contributing to the growing trend of PM<sub>2.5</sub> concentration in HCMC. This is believed to have been a factor in the elevated PM<sub>2.5</sub> levels observed during the renovation period. The PCR project will address this issue through further studies.

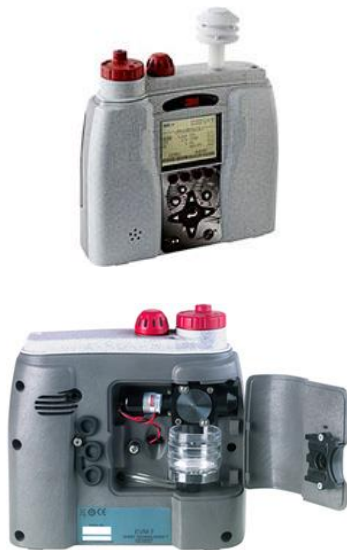
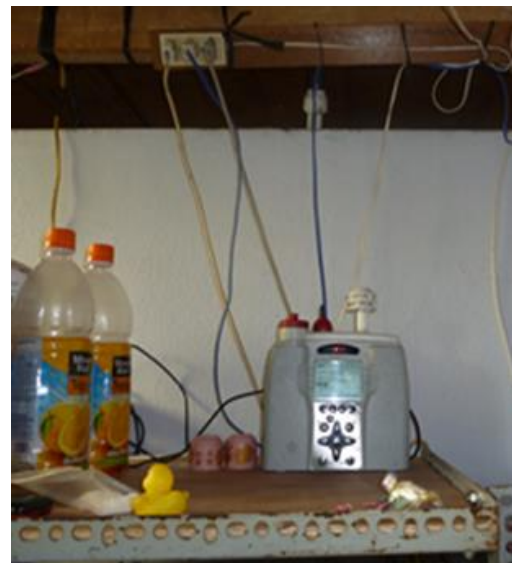
Figure 3. The indoor air quality monitoring device - the 3M™ EVM series environmental monitor model EVM-7

The 3M™ EVM series environmental monitor - model EVM-7

The EVM-7 monitor in a sample house

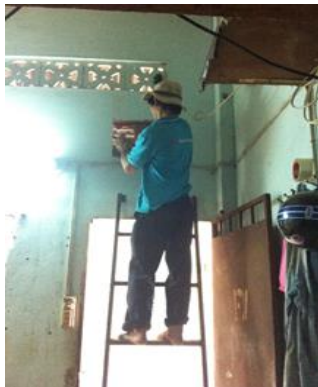
(a) Installation of Exhaust Fan through Brick Wall

- The house was equipped with a mechanical extract ventilation system, which was installed and operated during activities such as cooking, smoking, burning incense, and sleeping.
- The doors and windows were temporarily closed in the morning when the occupants went out and opened again, then closed for a short nap at noon and opened again.
- The doors and windows were kept closed all night.
- A motorbike was parked inside the house during the night.

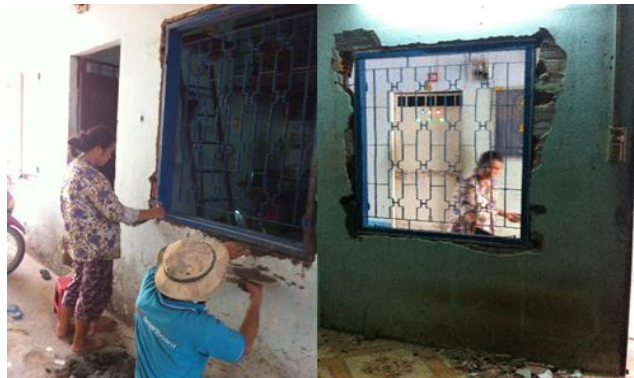
(b) Upgrade and Replace the Previous Window. The new window was a type of louvered window that has fixed horizontal slats to allow for air to flow through

- A new larger louvered window replaced the old steel window.

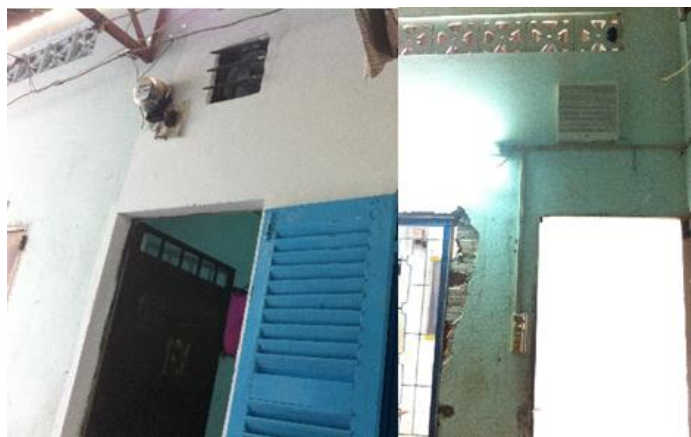
Figure 5. Some photos taken during the renovation of the sample house

(c) The sample house underwent renovation with the installation of a new window and an exhaust fan

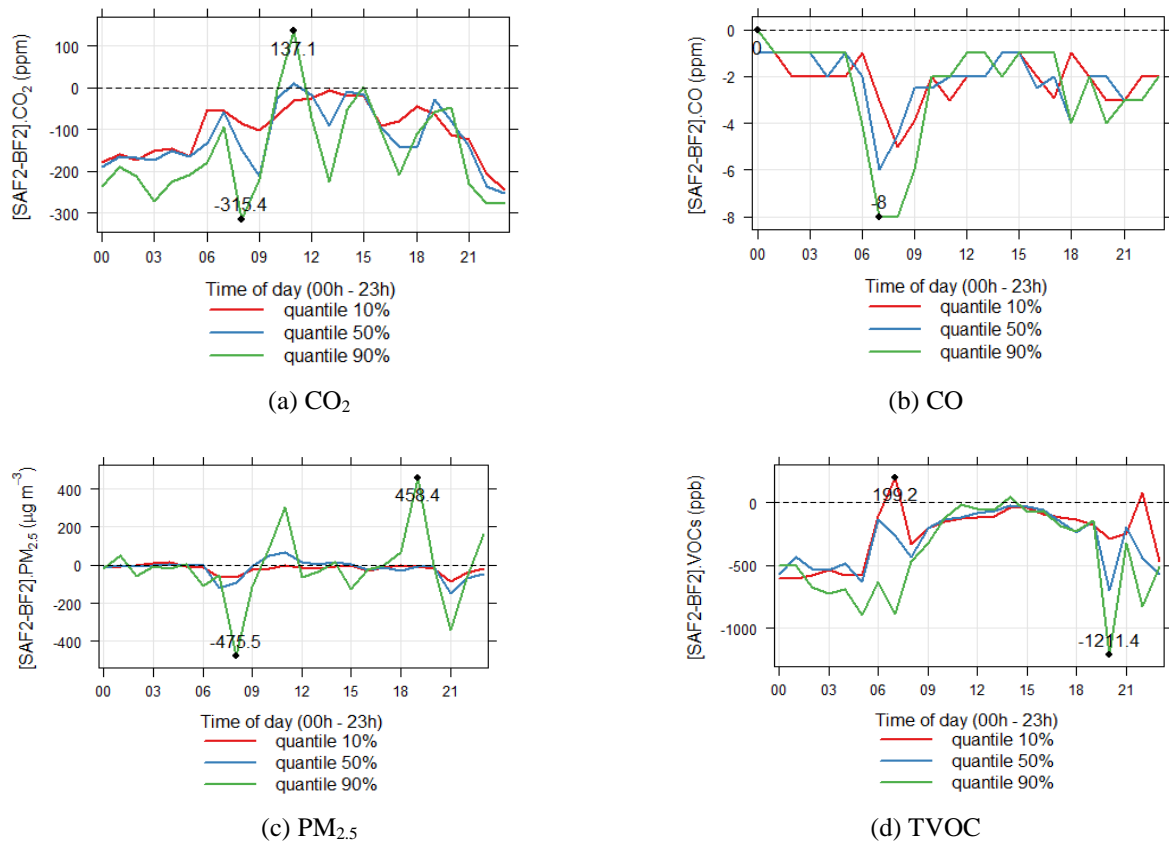
As shown in Table 3, the mean values of CO<sub>2</sub> during the day and night were 509.8 ± 54.1 ppm and 531.5 ± 22.8 ppm respectively, with a maximum of 741 ppm. As illustrated in Figure 7a, all quantiles of CO<sub>2</sub> were lower during the day in the renovated condition (AF) compared to the before renovation condition (BF), with differences reaching up to 300 ppm. CO<sub>2</sub> concentrations remained low and stabilized at around 500 ppm throughout the day, which was lower than the measurements before renovation. The average CO concentration ranged from 0 ppm to 8 ppm and did not exceed the standard. These results were better than the measurements before renovation. The indoor PM<sub>2.5</sub> concentrations fluctuated from 25 µg/m<sup>3</sup> to 1,547 µg/m<sup>3</sup>, with average concentrations recorded during the day and night being 107.8 ± 119.7 µg/m<sup>3</sup> and 70.4 ± 100.2 µg/m<sup>3</sup>, respectively. PM<sub>2.5</sub> concentrations in the renovated condition (AF) were still high, with 64% of readings exceeding the Vietnamese standard during the day and 63% during the night.

The differences in PM<sub>2.5</sub> concentration between AF and BF were shown to be similar in the plot of (AF-BF) PM<sub>2.5</sub> concentration (Figure 7c). The indoor TVOC concentrations fluctuated between 141 ppb and 1,930 ppb, with average values of 324.3 ± 204.8 ppb during the day and 606.9 ± 147.2 ppb during the night. As seen in Figure 7d, all quantiles of TVOC were lower in AF compared to BF during the day, with differences reaching up to 1,210 ppb, especially during the evening and sleeping time. The use of an exhaust fan along with the new large louvered window was found to allow for better ventilation, thus reducing the indoor TVOC concentrations from the old motorbike stored in the room. However, 11.4% of TVOC readings during the day and 74.2% of TVOC readings during the night were still above the recommended value of 500 ppb due to the occupants not regularly using the extractor fan.

Figure 7. Quantile differences of pollutant concentrations between AF and BF
